A Report on the Schools of Boston - 1962.

Boston Redevelopment Authority, Mass.; Harvard Univ., Cambridge, Mass.

A R E P O R T O N T H E S C H O O L S O F
B O S T O N

MAY 1962

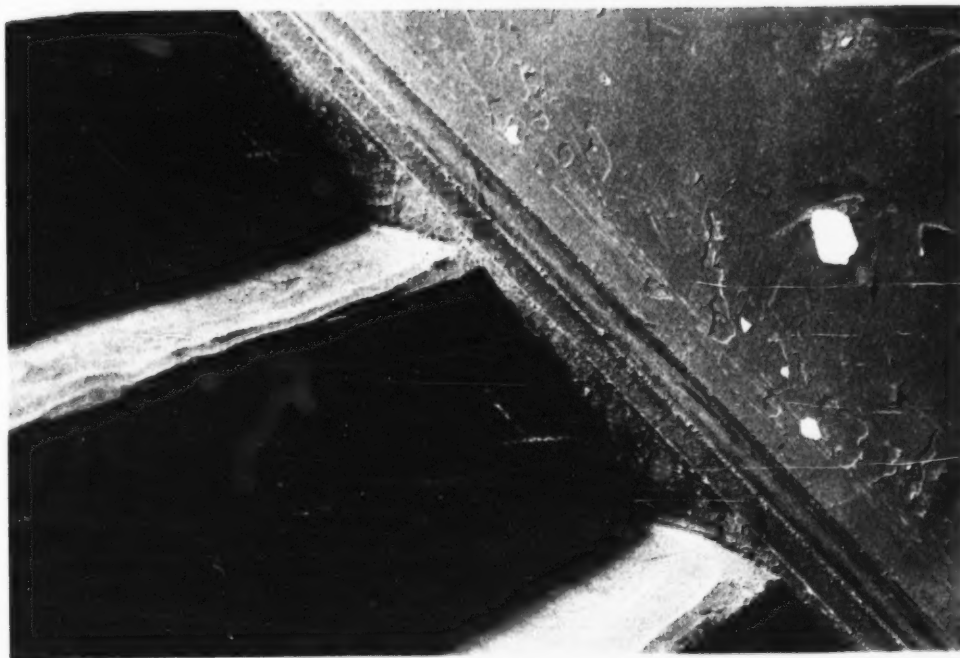
In many of these older schools, the stairways are narrow, poorly lit, and made of wood.

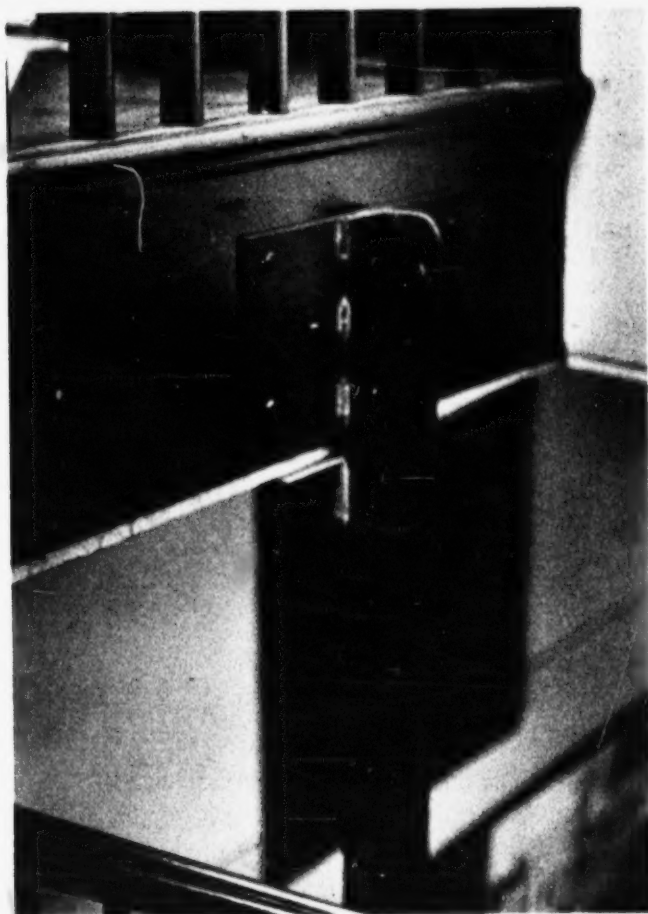
In some cases, the stairs are worn and the paint is chipped.

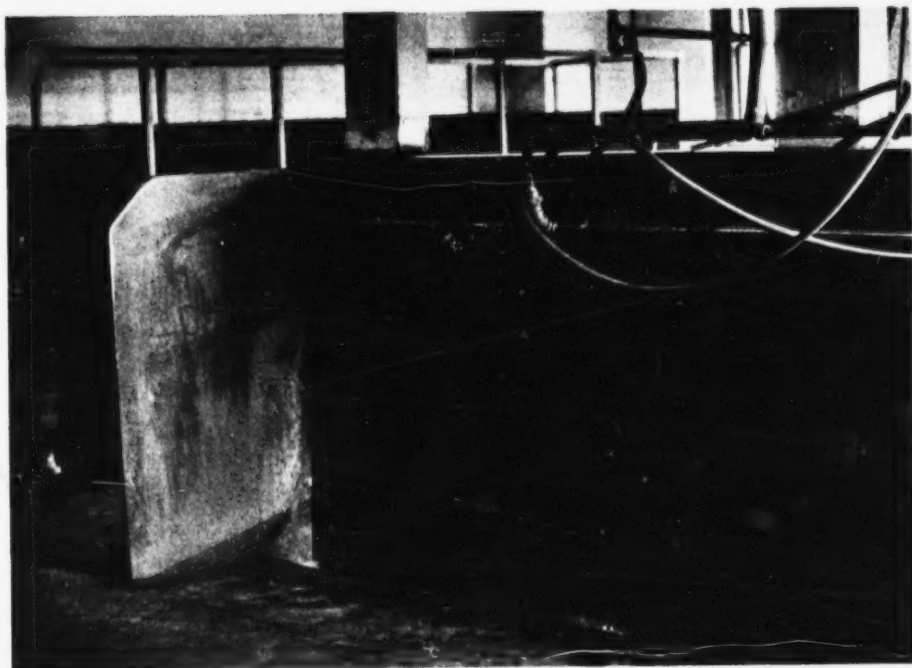
In other cases, the wooden stairs are supported by a metal brace.

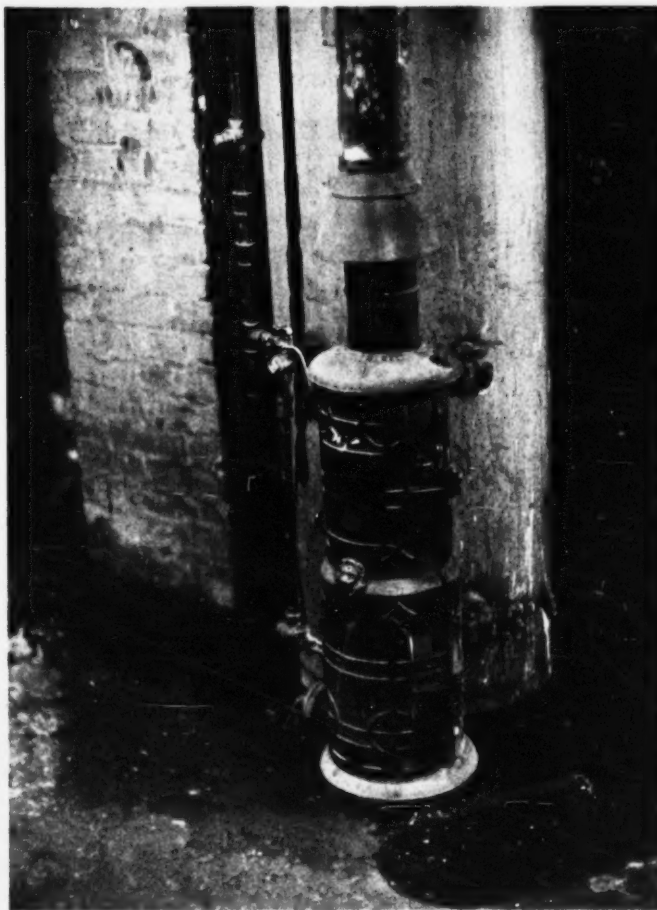
In some cases, the heating equipment is by contemporary standards crude at best. Many of the furnaces are still hand-fired with coal.

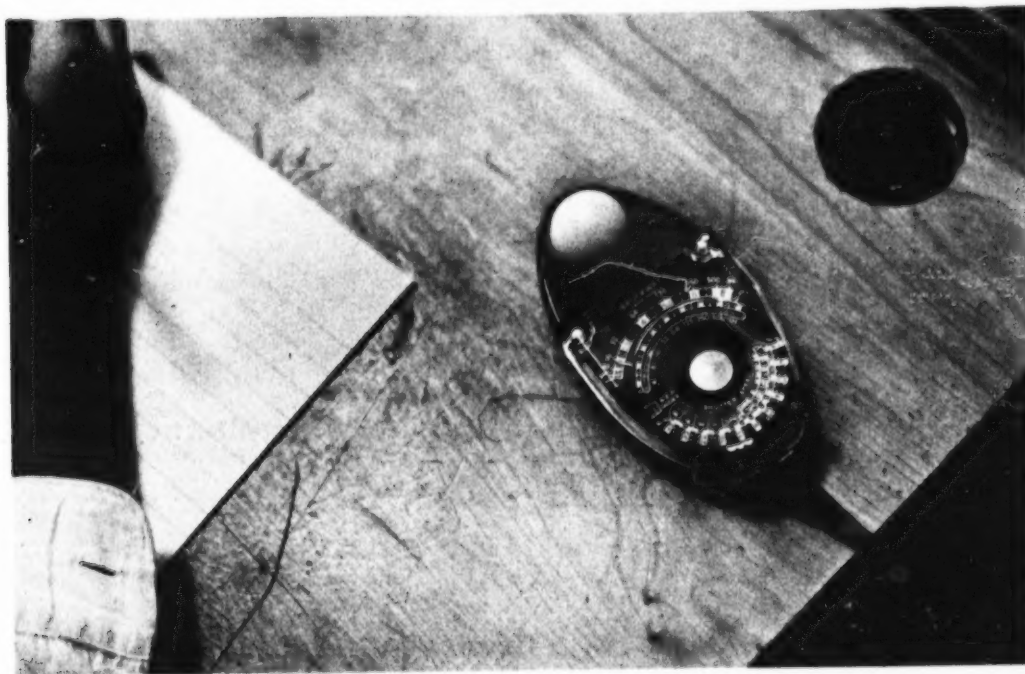
Perhaps the one factor in schools that has changed most impressively over the years is the standard of lighting provided. In older days, five footcandles at the student's desk was considered adequate. In 1952, the Illuminating Engineering Society recommended 30 footcandles and recent recommendations have run as high as 70 footcandles for the more intricate desk work.

Here, a light meter placed on a student's desk in a typical older classroom on a sunny day reads 12 footcandles.
